## Vue Condominium Transition Warranty Analysis & Litigation Support

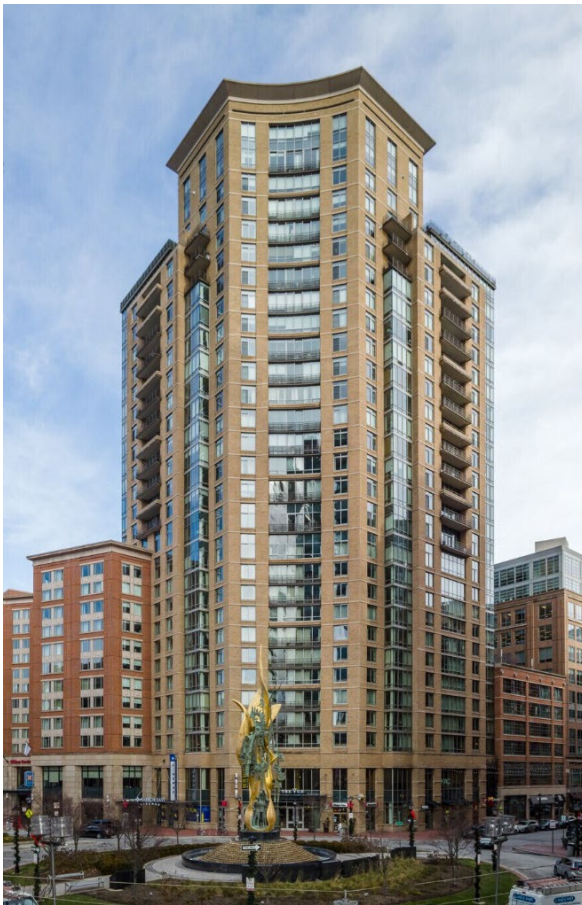
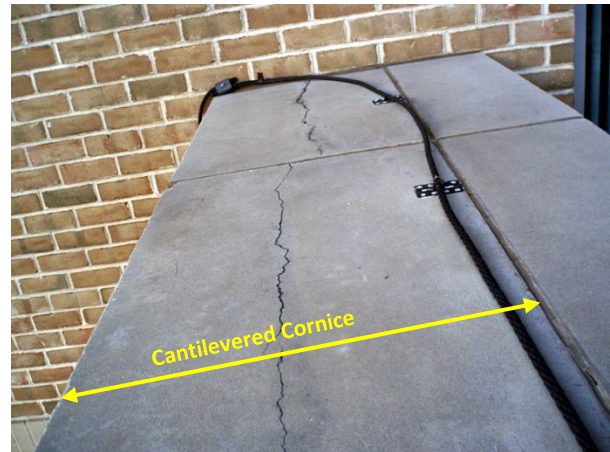
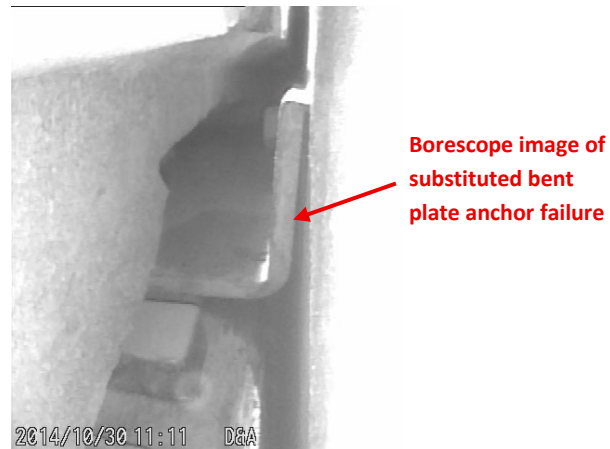
- Rapid Identification of Life-Threatening Defects: At commencement of the investigation, D&A observed a predominant pattern of cracks extending down the length of the cast stone cantilevered cornice. The crack pattern on the stones were photographically documented for analysis. The top and underside cracks aligned indicating that the cracking was becoming full depth and the outer half of the **stones were separating from the building and in imminent danger of falling 29 stories** onto the public sidewalks and road below (top right photo). None of this was realized by the numerous forensic consultants retained to correct the water infiltration prior to D&A.

- In-House Borescopic Testing Advantages: D&A borescopic equipment was able to extend through the narrow sealant joints flanking the cast stone coping. This substantiated and documented that the cracks were extending full depth through the cantilevered cornice stones. It also revealed unidentified deficiencies including that the concealed steel angle anchors, which were the sole support for the cantilevered stones, were substituted with far weaker bent plates that were deflecting and pulling out causing the stones to rotate (bottom right photo). Continued borescopic analysis substantiated that the installation of deficient steel anchors was consistent on all sides of all terraces and, therefore, systemic. A joint investigation was performed so that the developer's forensic engineer could repeat the borescopic investigation to determine the validity of D&A's findings. **The equipment of the forensic engineer was of much lower caliber and could not fit through most of the joints. Without this information the forensic engineer's remedial scope recommending repairing cracked stones in place would not have prevented stones from falling.**

- In-House Pacometer Analysis of Cast Stones: This equipment is a nondestructive method to determine the depth and size of steel reinforcing in concrete. The developer represented that the cornice stone may have incorporated transverse steel reinforcing and therefore the cracks are stable and replacement of the stones was not necessary. In response D&A investigated the steel reinforcing placement in the cantilevered stones in the presence of the developer's forensic engineer.

- Value Added: The pacometer not only confirmed the absence of transverse reinforcing but also substantiated that a notable number of stones had reinforcing discontinuous and at incorrect locations. This ended the prolonged remedial negotiations regarding leaving the stones in place.

- Value Added: By substantiating these concealed conditions were systemic and in imminent danger of failure the developer, at their cost, erected staging and temporarily secured all stones with stainless steel pins and epoxy injection into the cracks. Without borescopic analysis the final remedial scope would not have included replacing the failing steel anchors.

- Alternate Remedial Design Resulting in Settlement: A cash settlement offer, which included funds to replace the cast stone cantilevered cornice, based on a proposal obtained by the developer from a restoration contractor, was rejected by the association due to obvious scope omissions in the proposal and the total offer amount being too low. D&A prepared construction documents which incorporated a unique staging and hoist method to remove and reinstall the heavy cast stone that was notably more time efficient and cost effective. A bid for this work reduced the cost by **XX%** which resulted in a revised cash settlement offer being accepted which ended the litigation. The work was implemented at this cost without change orders.
