## Metropolitan Apartments – Concrete Balcony Restoration Forensic Analysis, Repair Design & Construction Phase Quality Assurance

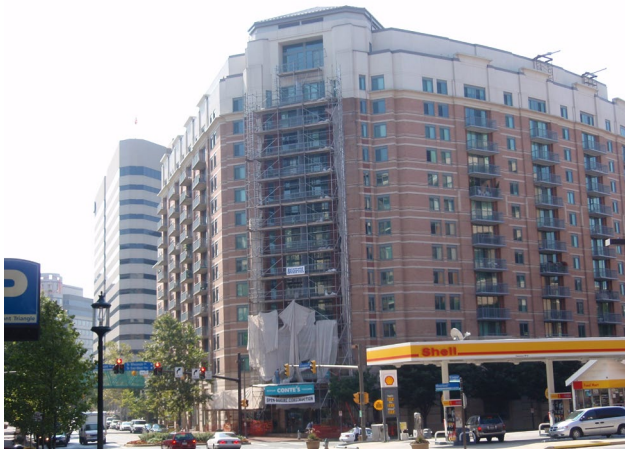
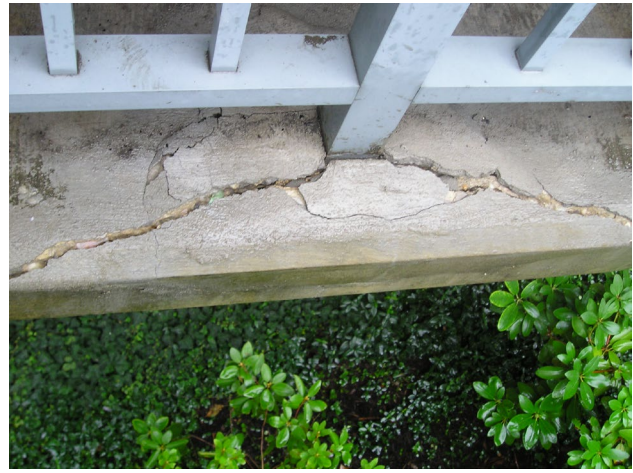
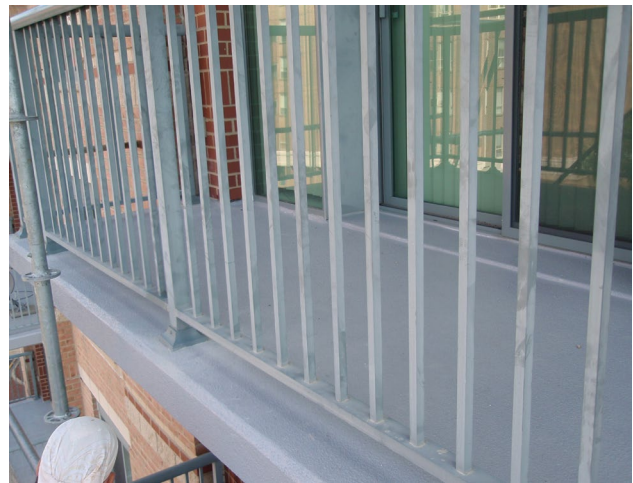
**Challenge:** Analyze the nearly systemic failure of concrete around the embedded guardrail support posts at balconies and develop appropriate, cost effective repairs to restore concrete integrity and mitigate future damage, while maintaining access to ground floor retail and pedestrian safety.

**Value Added:** Through the use of visual observations, non-destructive testing, material sampling and laboratory analysis D&A was able to verify the use of expansive, gypsum-based grouting material at the support posts, deficiencies in original concrete finishing, and inadequate coverage of the reinforcing steel, causing the concrete failures. This allowed the owner to avoid enacting prior repair recommendations that would not have addressed the root causes of the deterioration. D&A developed a comprehensive repair scope and provided Construction Quality Assurance services throughout the duration of the construction phase of the project.

**Services performed:** Forensic analysis, repair construction document and specification preparation, bidding and contract negotiations, and quality assurance during construction.
