Argentine Naval Attaché Building  
630 Indiana Avenue  
**Historic, Forensic Investigation & Analysis**

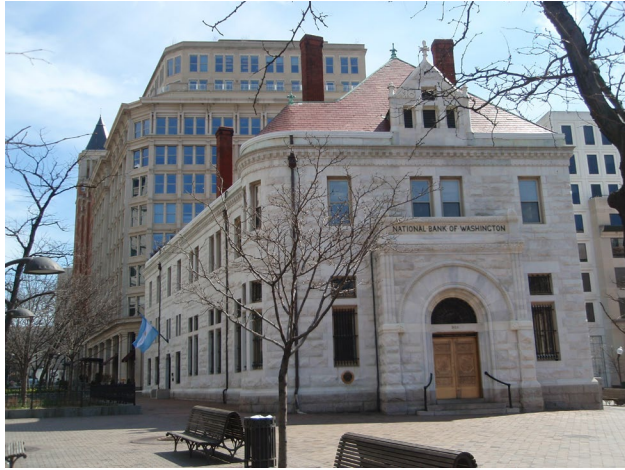
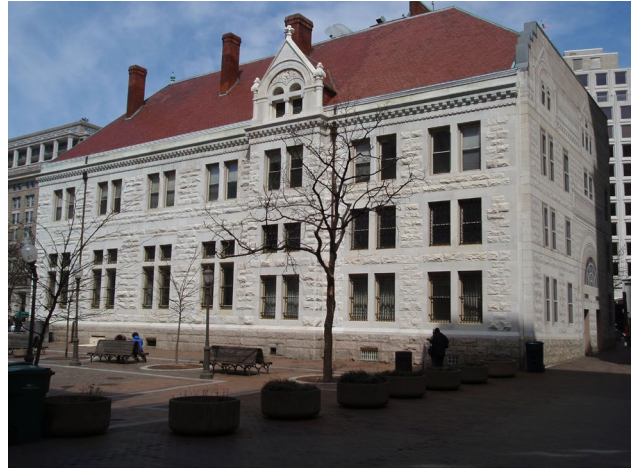
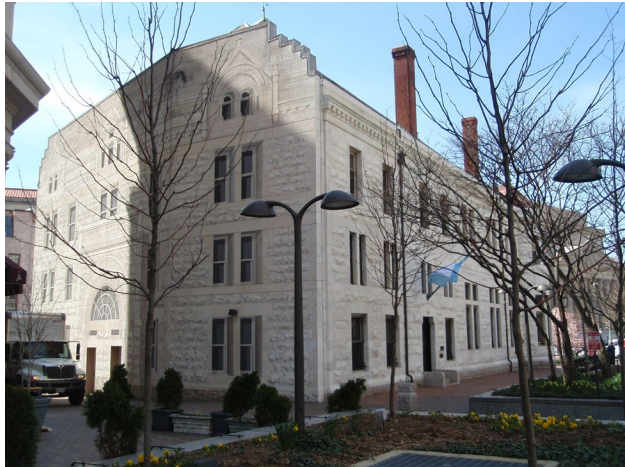
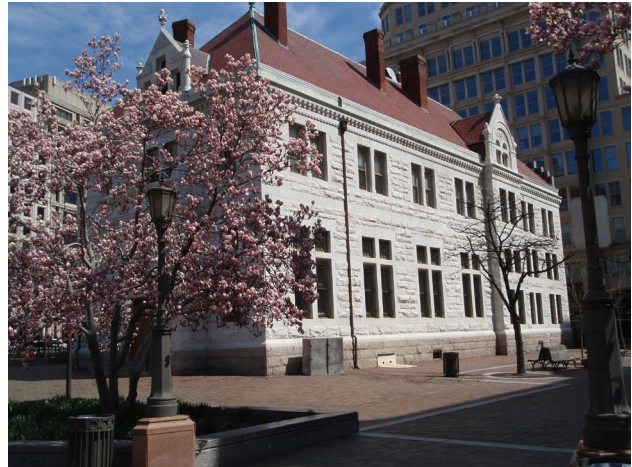
Due to construction of the adjacent office building to the east in or around 1987, structural damage occurred, including movement in the basement slab and settlement of the structure. The damage included stress cracks in the stone façade, especially at the junction of the east and west wings, interior wall cracks, floors pulling away from the party walls and distortion of the roof planes.

**Challenge:** Design repairs which would be undetected on the exterior of this Historic structure.  
**Value Added:** Davidson & Assoc. worked with the Structural Engineer to design façade repairs, including the installation of custom cut stone blocks to conceal the settlement cracks after the structures had been stabilized.  
**Service performed:** Forensic Investigation / Analysis and design of façade repairs for this Historic structure.  
**Client:** Spiegel Zamecnik & Shah, Inc. Structural Engineers.
